Manhole Inspection Summary

Manhole # S29I__051MH

Location Address: **820 Parkin-MLK Jr**

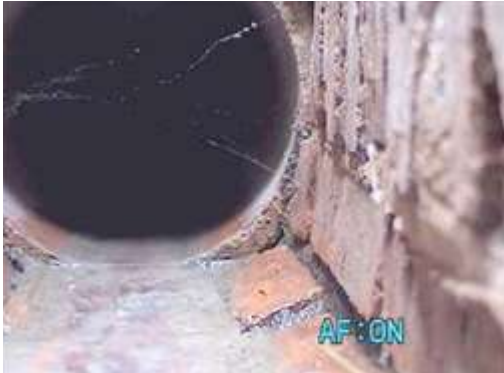
Defect 6

mortar missing channel

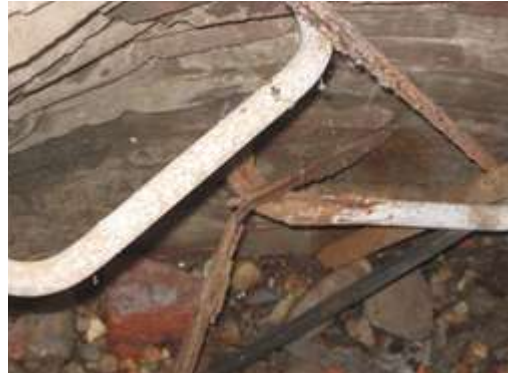
Defect 5

corroded rungs

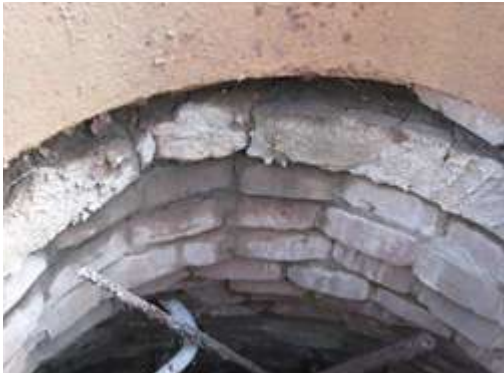
Defect 4

infiltration frame/chimney

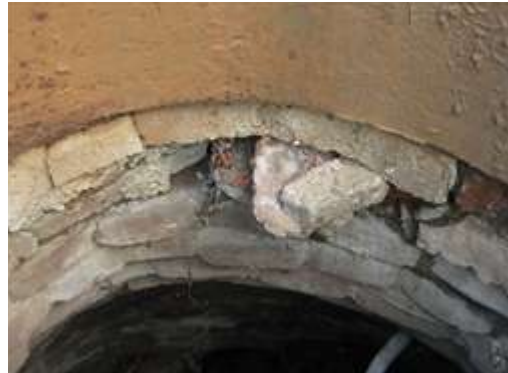
Defect 3

loose bricks, missing mortar infiltration lid/frame

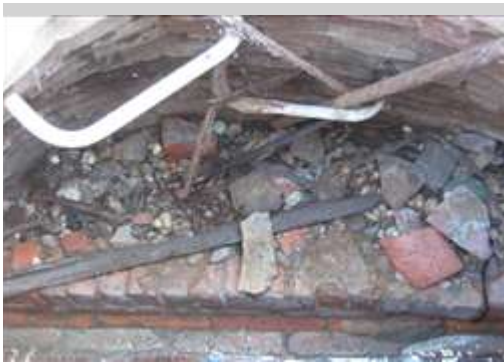
Defect 1

Bench Debris

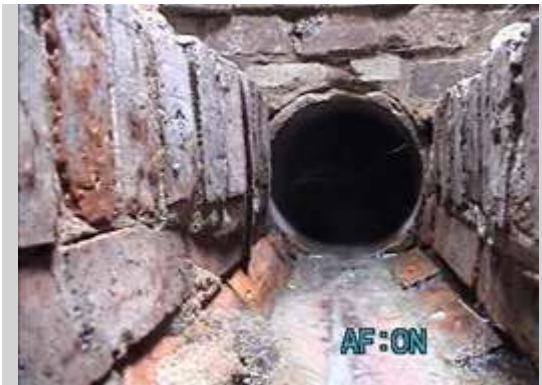
6 O'Clock Inflow

Pipe Height: **8.4** (in.) Rod and Bar (Angled)
Pipe Material: **Clay** ☐ Pipe Lined
Invert Depth: **5.60** (ft.) Flow Characteristics: **Slow**
Deposits: ☒ None ☐ Mud ☐ Sludge ☐ Debris ☐ Grease
Silt Depth: **0** (in.) Deposits Extent:
Infiltration: **None** Pipe Seal Cond: **Cracked**
